Federal Pacific Electric

Douglas Hansen & Redwood Kardon

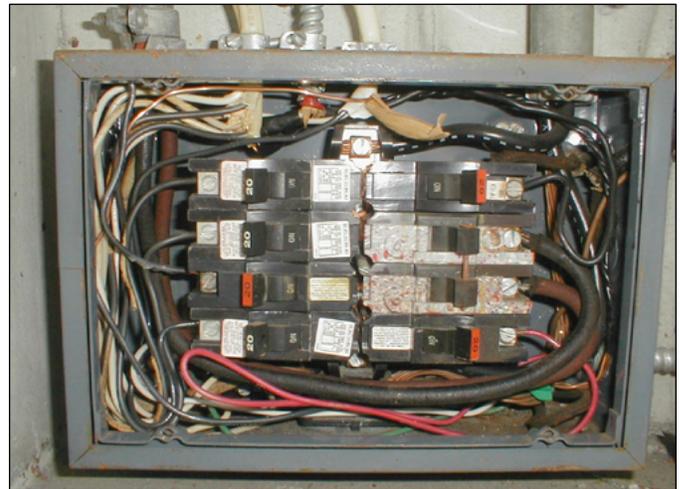
Figure 1 - Crowded FPE Panel

Several of FPE's problems are typical of other old panels. There is less wiring space, especially opposite main lugs and breakers, and the result is a crowded panel (figure 1). Over the years, the minimum wiring space required in codes and standards has increased. Significant changes occurred in the 1981 NEC, near the end of FPE's existence as a panel manufacturer, when the amount of space was increased for conductors needing to make more than one bend to exit the panel.

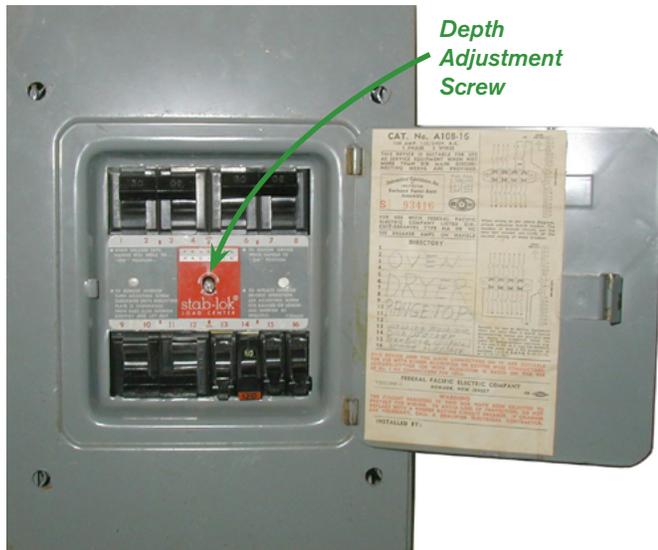
Figure 2 - 1960s FPE Panel

Since the 1984 edition of the NEC, breakers that operate with their handles in a vertical position must be on when in the up position, and off in the down position. Prior to that time, several manufacturers made equipment such as that seen in figure 2, with a row of breakers that was on when down and off when up. The word “on” when upside down is “no.”

Inspectors might find that their first challenge with FPE is the difficulty in removing the deadfront cover without tripping the breakers. Several models of FPE panels have breakers that are on when the handle is positioned toward the outside of the panels (figure 2). The handles stick out slightly over the deadfront, past the twist-out opening for the breaker. To remove the cover, it is necessary to first lift it slightly away from the panel, then to slide it under the handles of one row while lifting the cover off the other row. Once the cover has cleared the other row, it has to be slid back under the handles of the first row, and then it can be removed. If an inspector pulls the cover straight off, some of the breakers will accidentally trip. The spring-loaded bus mounts sometimes cause this to happen as soon as the last screw is loosened.

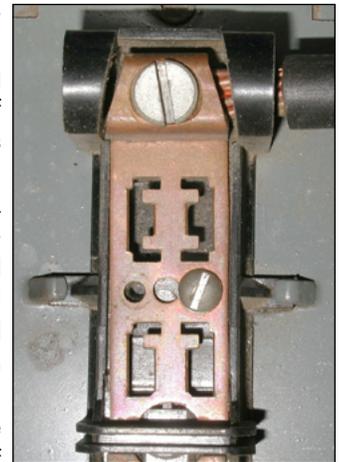
Figure 3 - E & F Sockets

Early FPE equipment had copper bus bars with the sockets cleanly defined (figure 3). Later FPE equipment used plated aluminum, which appears to have been stamped (figure 4). Some edges of the socket opening are slightly bent on these later models, further reducing the contact area of the breaker to bus connection.

As with other manufacturers, FPE made full-width breakers as well as tandem breakers, where two breakers fit into the same physical space as one full size breaker. UL has a standard for a “Class CTL” panel that limits the number of breakers based on the overall panel rating. CTL stands for “circuit total limiting” and residential distribution panelboards needed to be listed to that standard. To obtain the UL listing as a Class CTL panel, the number of tandem breakers had to be limited to conform to the overall rating of the panel. FPE accomplished this by having an “F” shaped bus socket for full width breakers and an “E” shaped socket for tandem breakers.

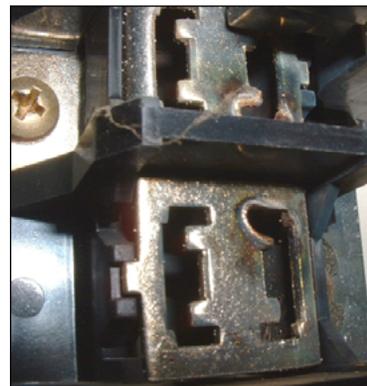
Figure 4 - Aluminum Sockets

Damage such as seen in figure 4 is quite common, though it cannot be seen until the breakers have been removed.

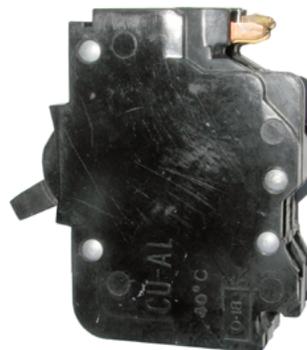
Figure 5 - 2-pole E Breaker

FPE breaker stabs were copper and formed with a bend to exert pressure on the edges of the bus socket. Pointed ends help guide the bus stab into the socket. The stabs on E breakers are remarkably fragile; and are easily damaged during installation. If the breaker has been pulled back out of the bus, the bus stabs become distorted and are often no longer parallel. The tension between the two stabs may be lost, and they do not securely snap into place. Loose breakers are a common problem with FPE. These loose connections overheat, and it is possible for arcing and damage to have taken place behind the breaker without visible damage to the front of the breaker. The damaged bus is not visible until the breakers are removed. The F bus stabs (figure 6) are more robust; the metal is more than twice as thick, and they are 3 times as wide as the E stabs (figures 5 & 7).

The F breaker stab is perpendicular to the direction the breaker handle operates, and the E stab is parallel to it. Note that an E bus slot will accept either an E or an F breaker, while an F slot will accept an F breaker or at most one E breaker.

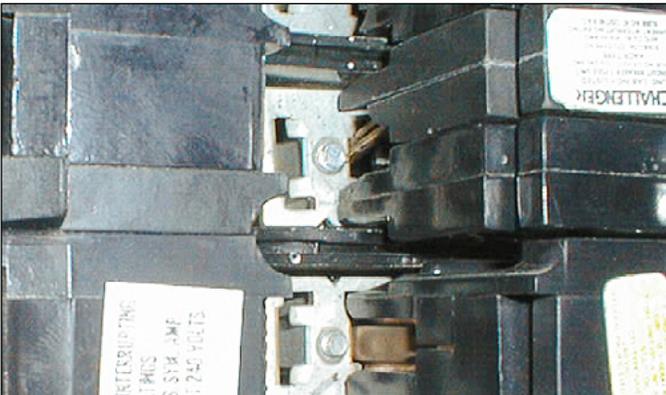
Fig. 8 - E Stab in F Socket

However, by bending the stab an E breaker can be forced into an F slot (figure 8), though this will damage the breaker. The plastic case may split open and the bus stab can recede into the breaker, as in figure 7. Since it then has very loose contact to the bus, the breaker might fall out when the deadfront cover is removed. Inspectors can be forewarned of this condition before taking off the cover. Look at the panel label to see where the E slots are located and whether any E breakers have been inserted into F slots. When finding that situation, there is no need to remove the cover to know that the breaker is in the wrong position.

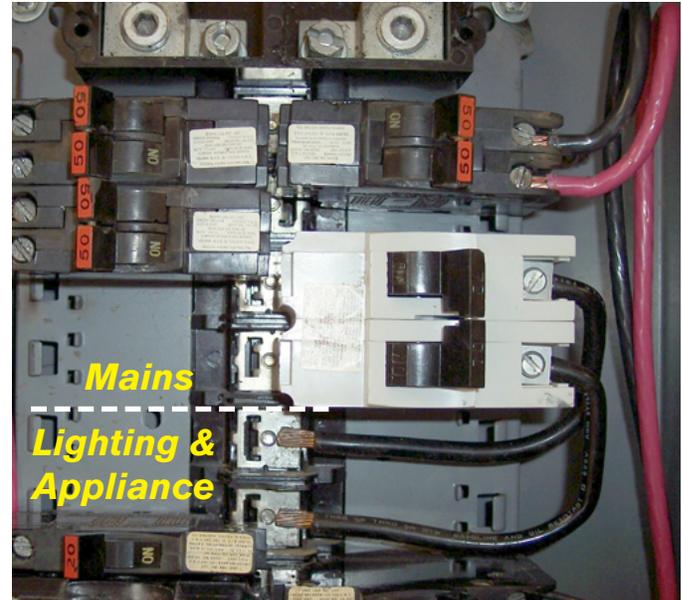
Fig. 9 - Split-Bus Panel

Where FPE differed from other split-bus panel manufacturers was in the method of connection to the lighting bus. On some FPE models the conductor from the upper breaker connected to a terminal, though on others it was simply soldered or brazed to the lower bus (figure 9). The NEC prohibits connections that rely solely upon solder [section 110.14(B)] yet allows connections made by brazing or welding. The heat necessary to connect these wires to the bus also can damage the plating on the bus, as in figure 9, and it is possible to install breakers on this same piece of damaged bus.

FPE also made split-bus panels. These functioned as service disconnects and load centers for branch circuits. The largest had room for up to six full-size 2-pole F style breakers. One of these breakers would feed the lower bus section which was to be used for lighting and appliance circuits.

As with many other brands, nothing prevented the installation of single-pole 120-volt breakers in the upper section that was intended for 240-volt breakers. Split-bus panels require that all of the breakers on the line-side bus be labeled as service disconnects in addition to labeling the specific use of the circuits.

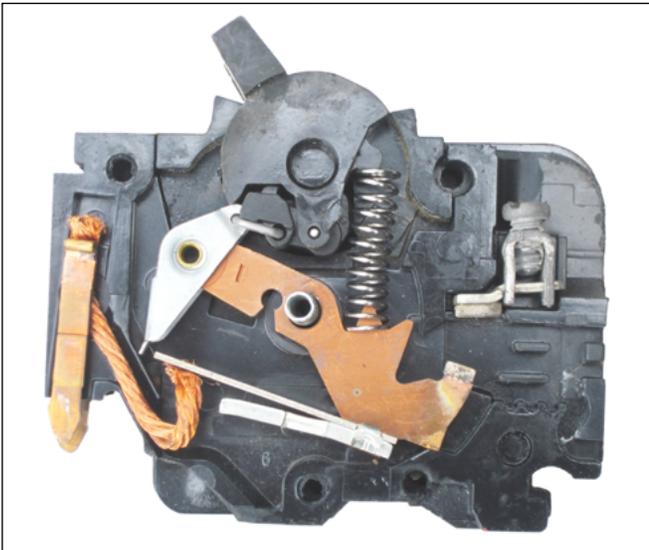
Fig. 10 - 2-pole E Stab Breaker

A spring is compressed when an FPE breaker handle is moved to the “on” position. That spring is the source of all the energy that will then operate the breaker mechanism when it needs to open. The series of mechanisms that must function for the breaker to open will remind older readers of the cartoons of Rube Goldberg. The copper armature must rotate on a shaft made of a steel coil spring, an arrangement that increases friction points and brings dissimilar metals in contact. Wires and rivets that act as shafts are in contact with dissimilar metals and molded plastics. The trip lever is activated by a “U” shaped piece of wire approximately the size of a staple that has one end in a plastic cam and the other end in the steel trip lever. The entire mechanical function of these breakers is only as good as the weakest link. The two-pole breaker in figure 10 has no fewer than 12 components that act as a shaft for a rotating part, and all 12 must move freely if the breaker is to operate.

One cause of failure can be the routing of the internal fine-stranded conductor that connects between the breaker stab and the bimetal strip. Under high fault conditions, the bend in this wire will contract, and slightly improper routing of it can contribute to the breaker freezing in the closed position in response to high currents. In other cases, this conductor was allowed to contact the steel electromagnet block, which can impede its function.

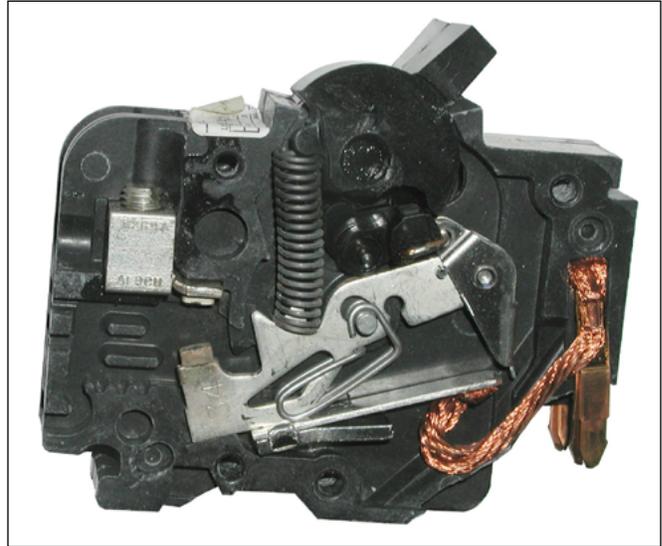
Fig. 11 - American brand 2-Pole Replacement Breaker

A clue to the problems with the FPE breakers can be found by looking at the subsequent breakers (figure 11) which did obtain listing by ETL after the initial FPE scandal. They improved them in several ways. Dissimilar metals are not in contact with each other, they used a solid shaft instead of a spring, and the wire connector was more robust. They also added a second spring to supplement the force of the primary spring.
